Site Visit Report		Project: WO-A-0106 - Inspection/Verification of Outstanding Punch List Items Rectification and Witnessing T&C of Systems at Gardez and Khair Kot Hospitals
Location: Gardez - Paktia, Khair Kot - Paktika		Contract: N/A
Inspection Dates: Gardez 100-Bed June 25, 2016 Khair Kot 20-Bed June 30, 2016		Coordinates: Gardez 100-Bed: N 33 37 47.73 E 69 13 53.32 Khair Kot 20-Bed: N 325053.29 E 682725.165
Project Inspectors: Gardez 100-Bed: Mohammad Shah Adli, Abdul Wali Waleed, Waleed Mahdi Khair Kot 20-Bed: Ayoub Ayoubi, Fattah Wardak and Faridullah Haidary	Status: N/A	Report Date: July 12, 2016

Tetra Tech, Inc.
Afghanistan Engineering Support Program
Contract No. EDH-I-00-08-00027-00
Task Order No. 1

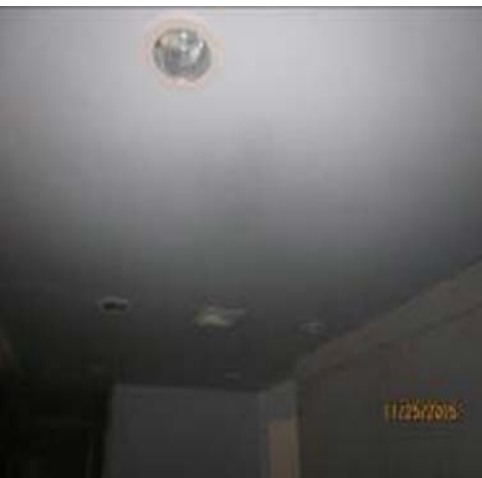
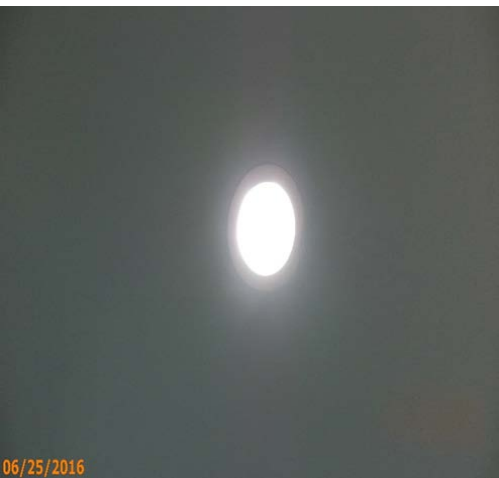
Item #	PL Items	Previous Status as of March 10, 2016	Current Status Per Tt's Observation as of June 25, 2016	Tt Comment
1	Total five number "D1" type lights glass covers are not installed at Main Entrance of Conference building, Conference building corridor

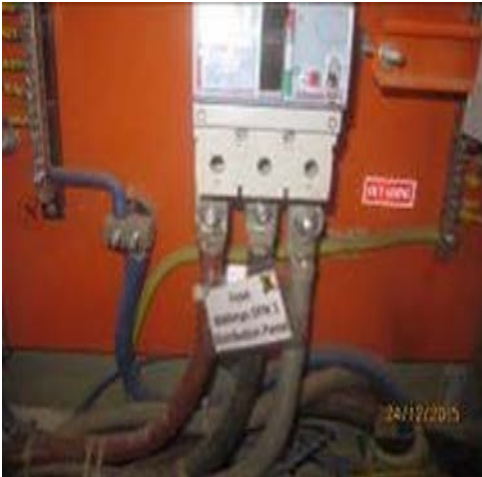
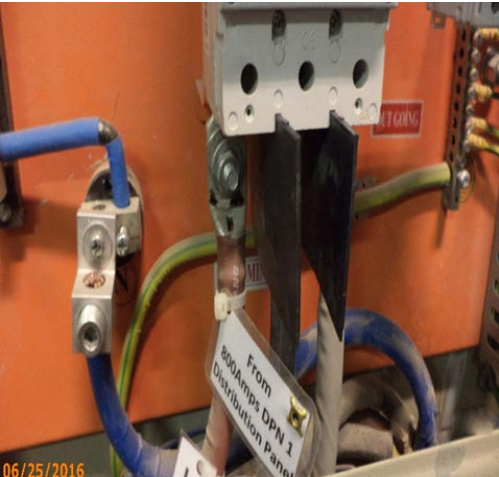
Closed
2	Phase separator was not installed for circuit breakers of mechanical room.

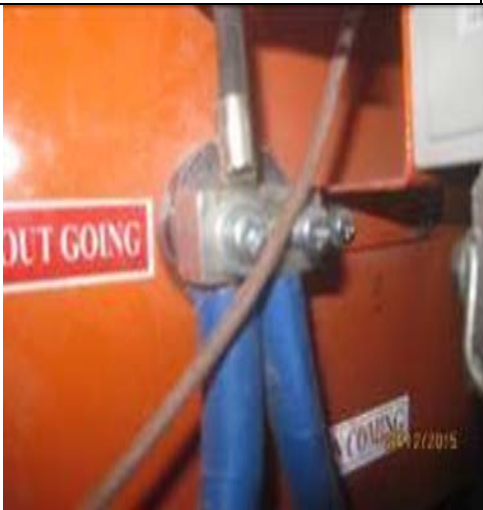
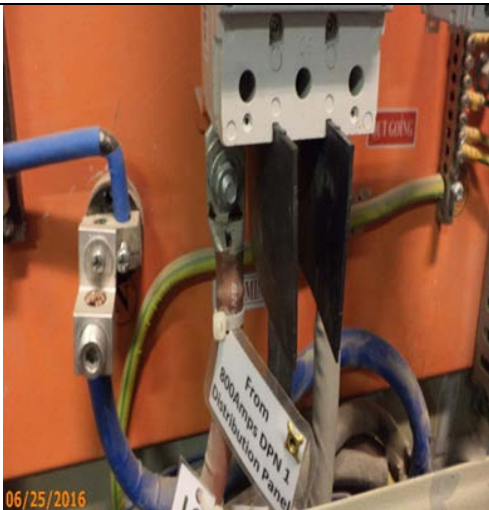
Closed
3	The contractor cut some segments of natural conductor in mechanical room panel boards.

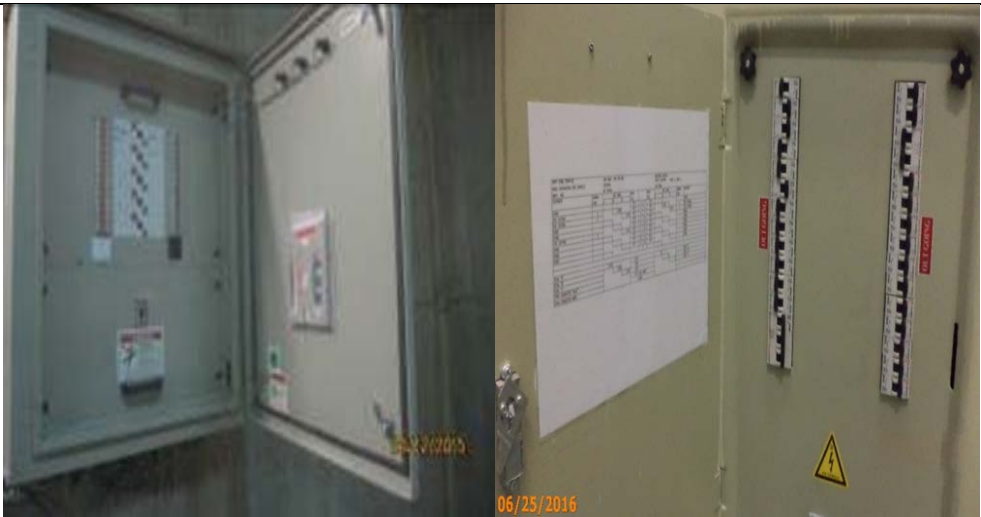
4	Panel board schedules were not installed for all panel boards of hospital building.

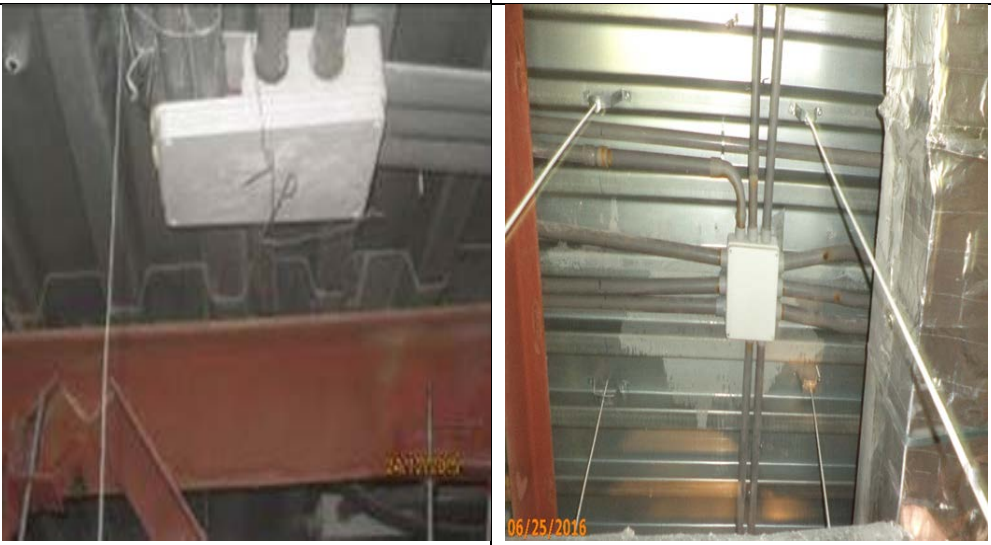
Closed
5	The joint box and cover of installed joint box in operation, recovery block, Male 1&2, Female 1&2 were broken requiring replacement also conduit glands were not used for installed joint boxes throughout the building

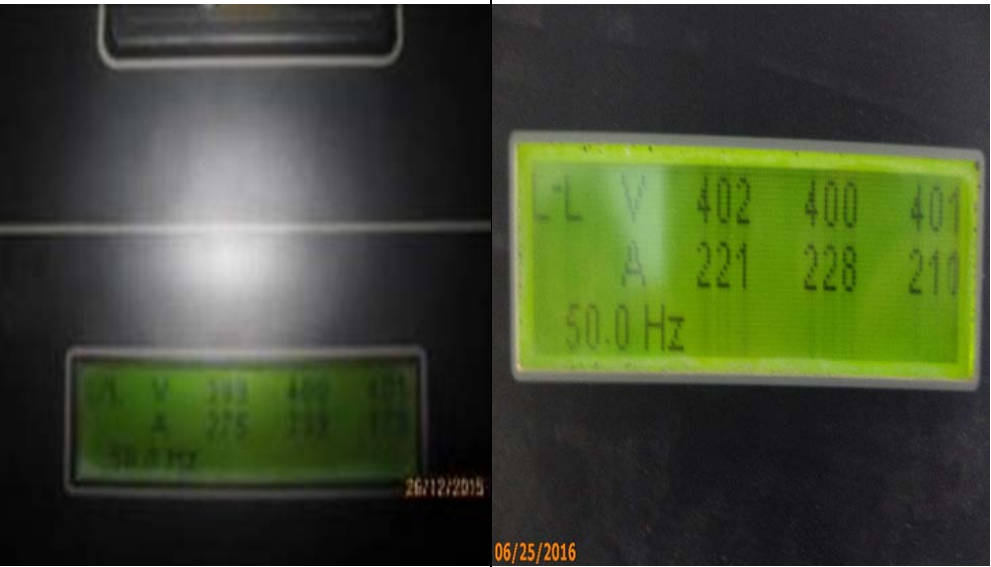
Closed
6	IOM conducted the Generators load test on December 24 and 26, 2015, test results are negative for both generators (500 kVa & 900 kVa) as load are unbalance, IRD shared this issue with IOM who promised that the load balance for each generator would be done after handover of the project.

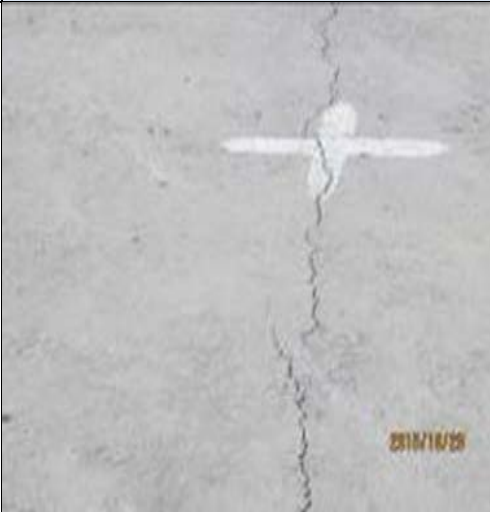
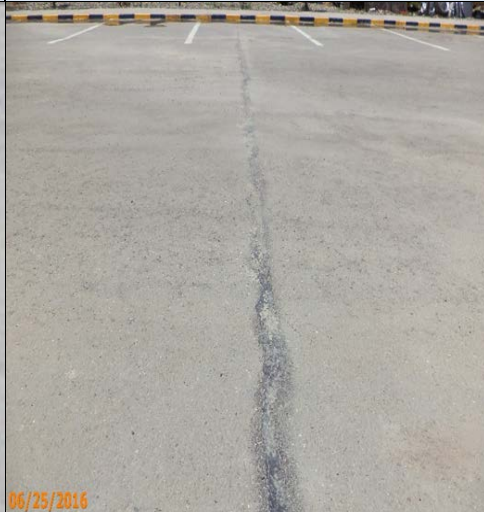
- The cracks in the asphalt wear surface of the road and parking area at west side of the main building and at the top of fuel storage tank's concrete slab were filled and repaired.

Item #	PL Items	Previous Status as of March 10, 2016	Current Status Per Tt's Observation as of June 25, 2016	Tt Comment
1	Cracks are clearly visible on the covered asphalt wearing surface of road and parking area at west side of main building and top of fuel storage tanks concrete slab.

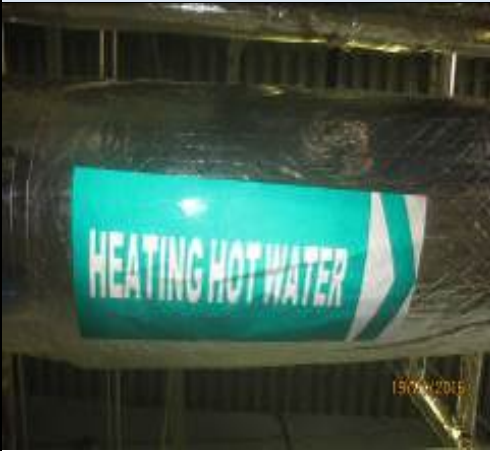
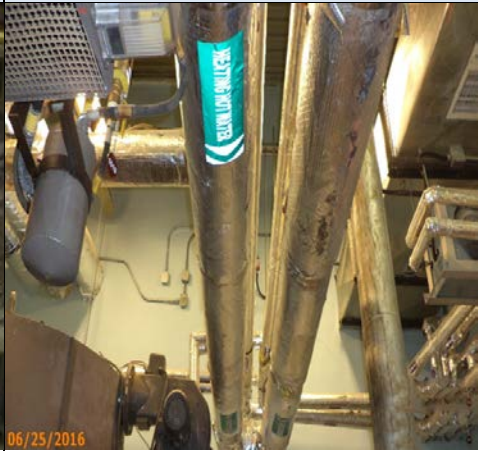
Item #	PL Items	Previous Status as of March 10, 2016	Current Status Per Tt's Observation as of June 25, 2016	Tt Comment
1	Installation of labeling for mechanical systems pipes is remaining.

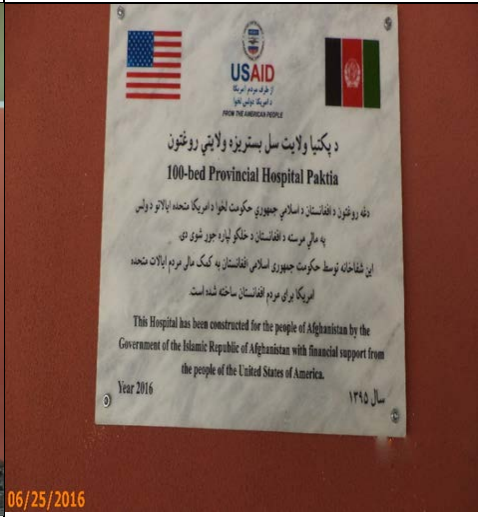
Closed
2	Installation of project main signboard is pending.

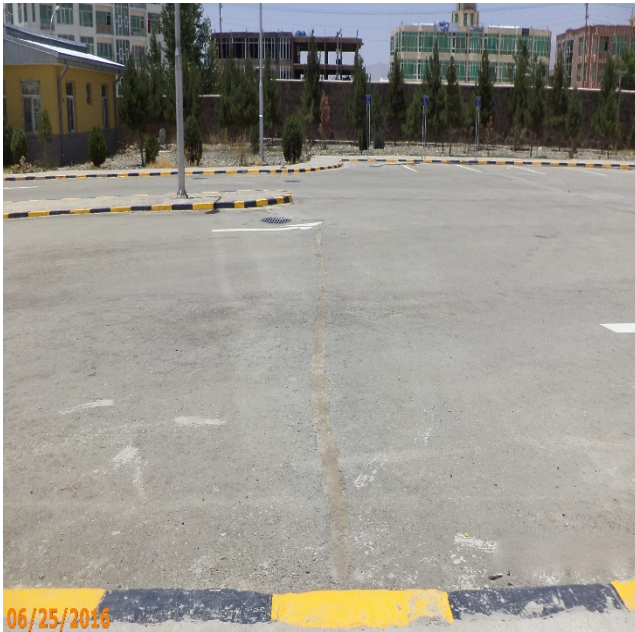
Photograph 1: The cracks were filled with bonding material MA, 06/25/2016.

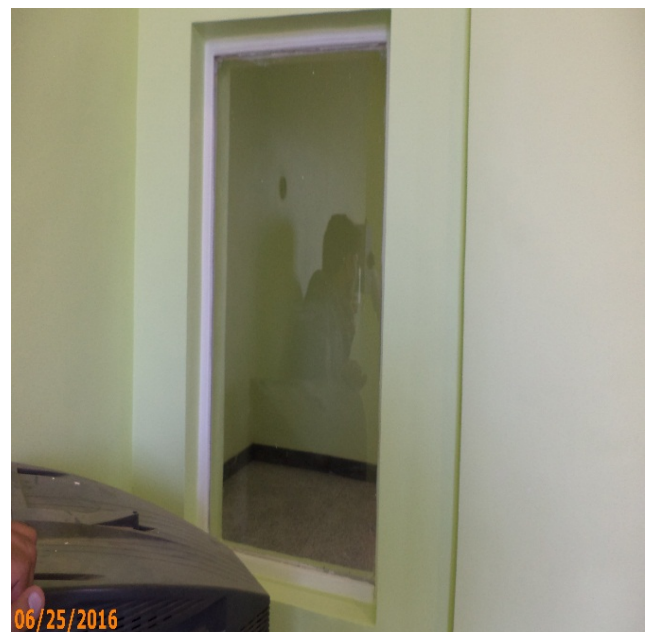
Photograph 2: The lead lined glasses installed at X-Ray Room, MA, 06/25/2016

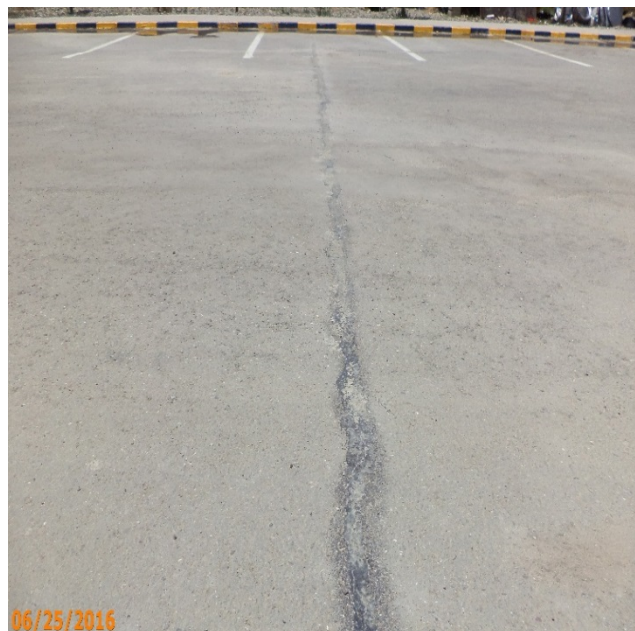
Photograph 3: The cracks were filled with bonding material MA, 06/25/2016.

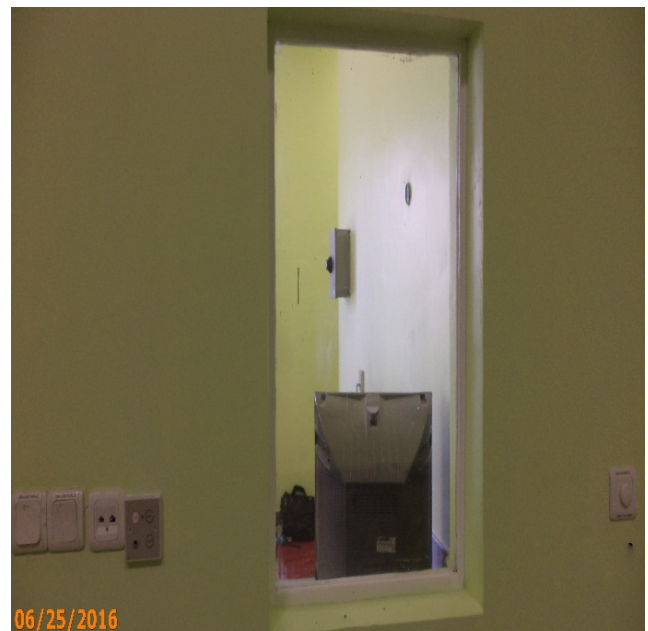
Photograph 4: The lead lined glasses installed at X-Ray Room, MA, 06/25/2016.

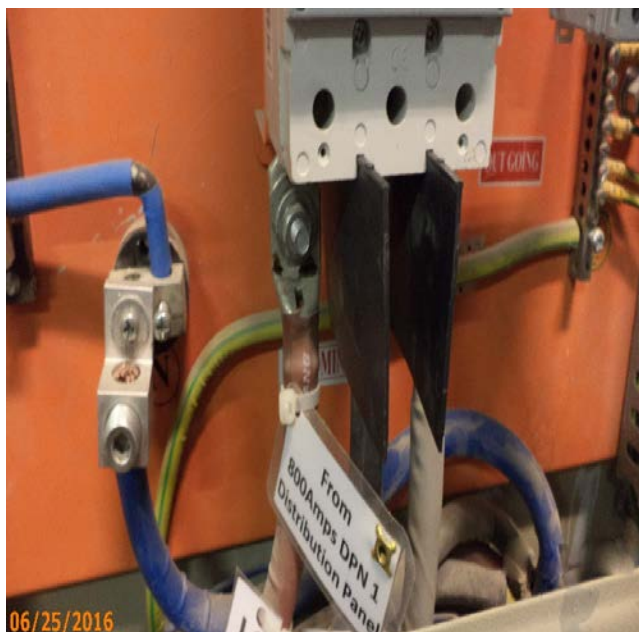
Photograph 5: The Phase separator and the segments of natural conductor, MA, 06/25/2016.

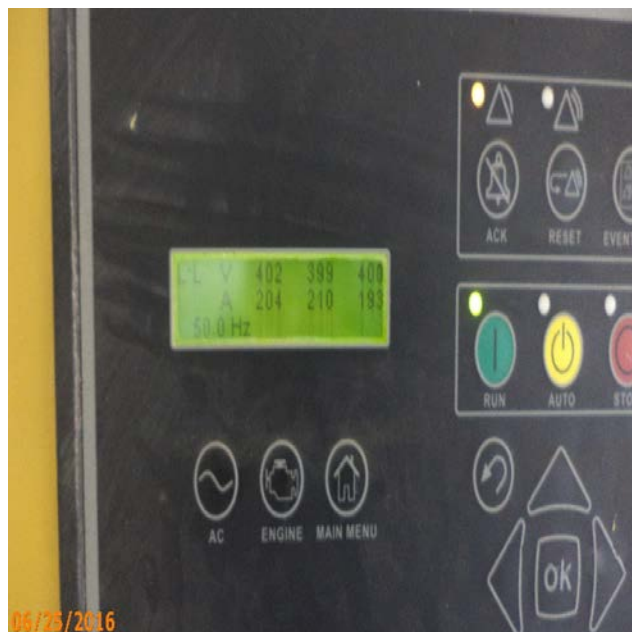
Photograph 6: Load balance for each Generator (500Kva & 900Kva) MA, 06/25/2016.

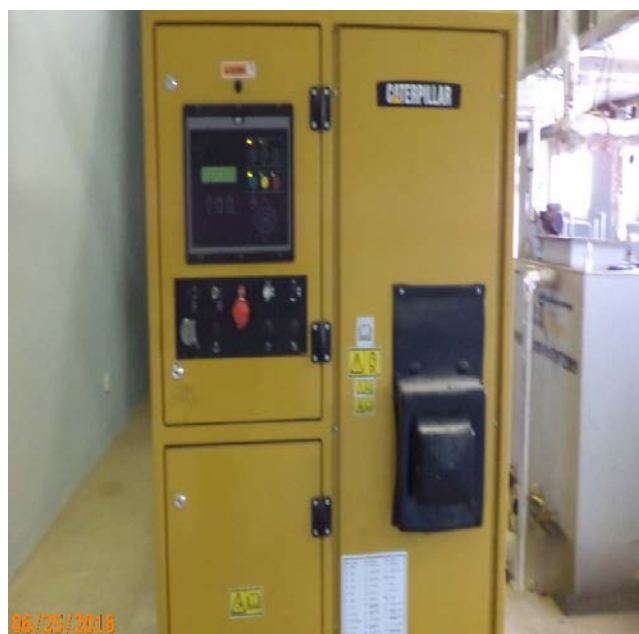
Photograph 7: 500kVA Diesel Generator was running during load balance, MA, 06/25/2016.

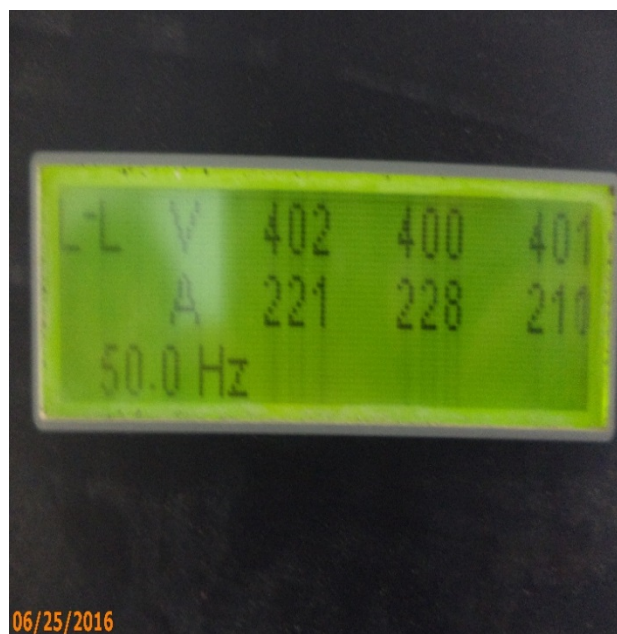
Photograph 8: Load balance for each Generator (500Kva & 900Kva) MA, 06/25/2016.

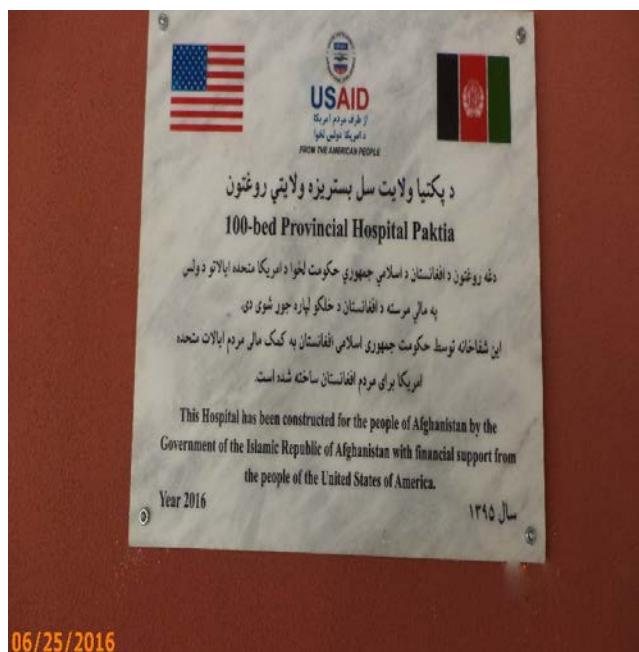
Photograph 9: Installation of project main signboard MA, 06/25/2016.

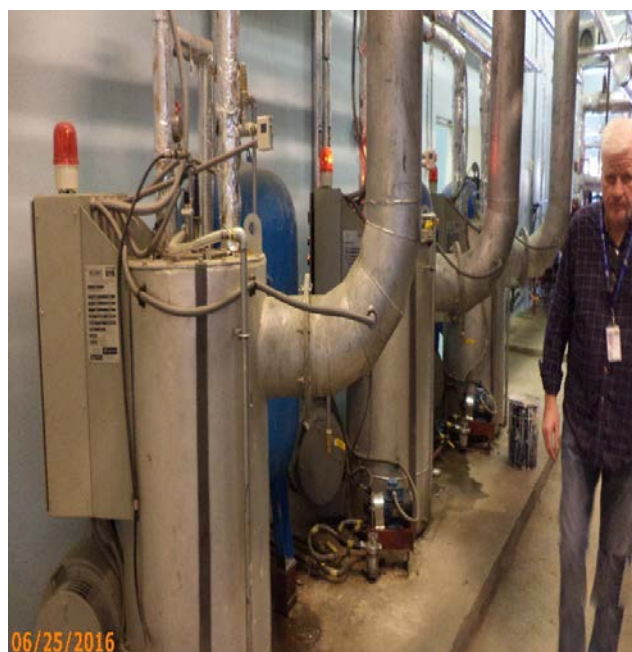
Photograph 10: The ignition Rod of the Boilers are repaired, MA, 06/25/2016.

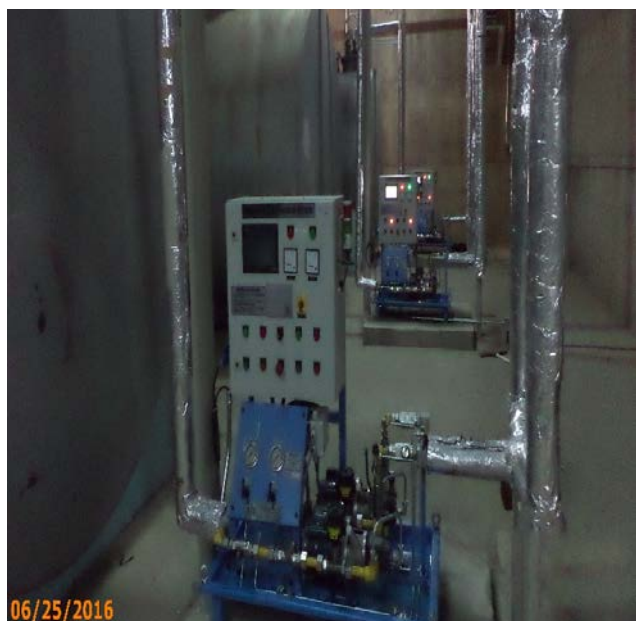
Photograph 11: IOM provided fuel and the pump control system installation was completed, MA, 06/25/2016.

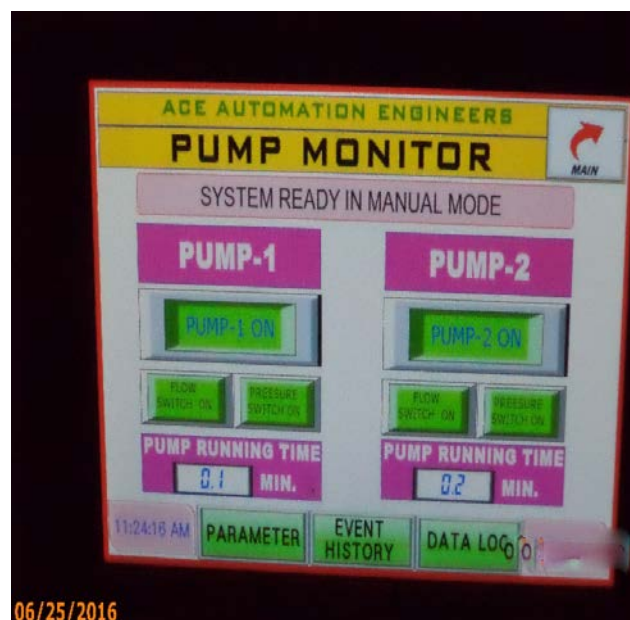
Photograph 12: The fuel pump control system installation was completed and the pumps were working, MA, 06/25/2016.

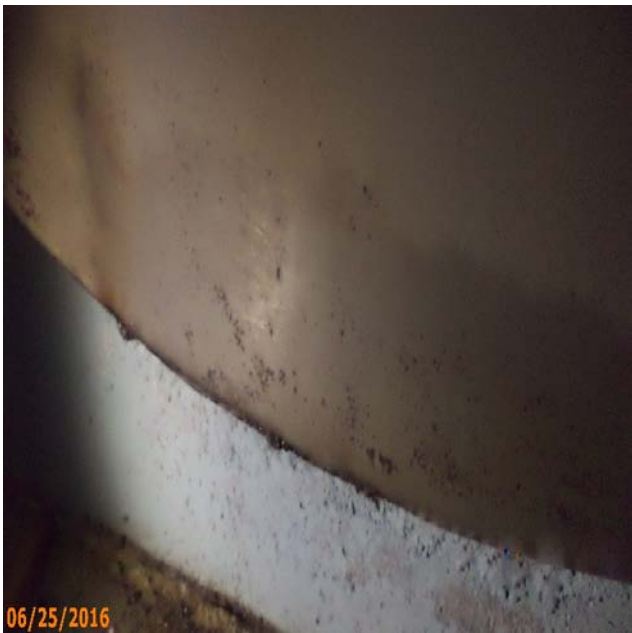
Photograph 13: The Lack at the lower side of fuel tank was repaired, MA, 06/25/2016.

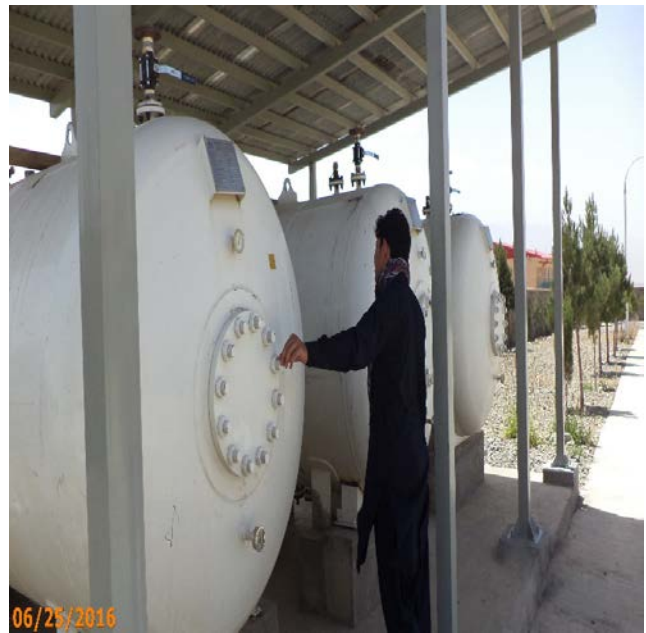
Photograph 14: The LPG Tanks were filled with 80% of its capacity, MA, 06/25/2016.

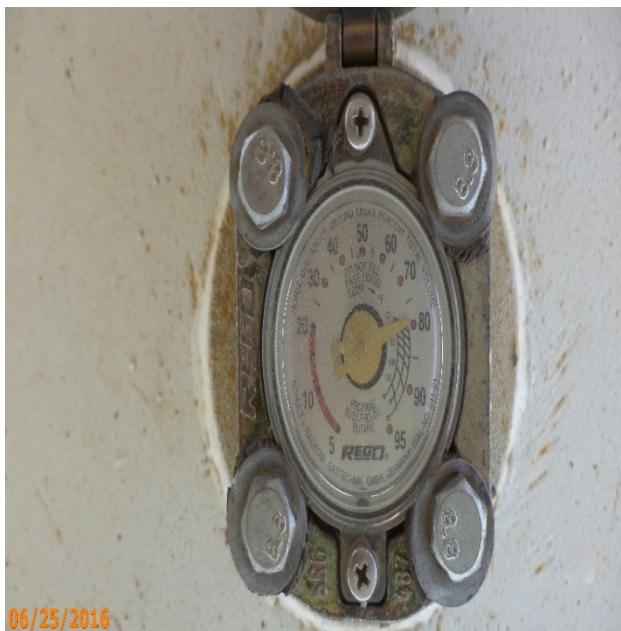
Photograph 15: The LPG Tanks were filled with 80% of its capacity, MA, 06/25/2016.

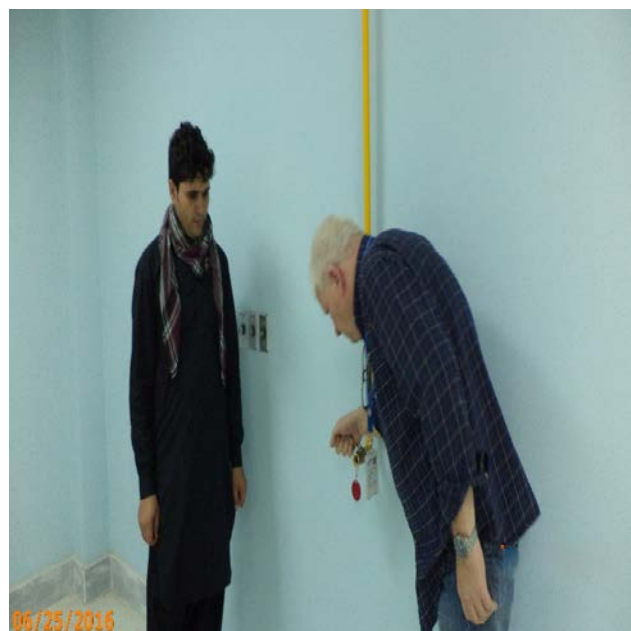
Photograph 16: The LPG Gas flows with enough pressure and velocity at outlet point in the laundry, MA, 06/25/2016.

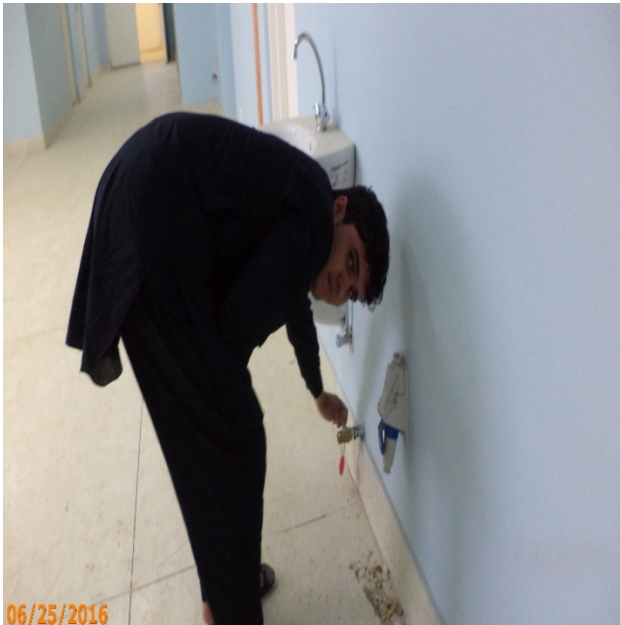
Photograph 17: The LPG Gas flows with enough pressure and velocity at outlet point in the kitchen, MA, 06/25/2016.

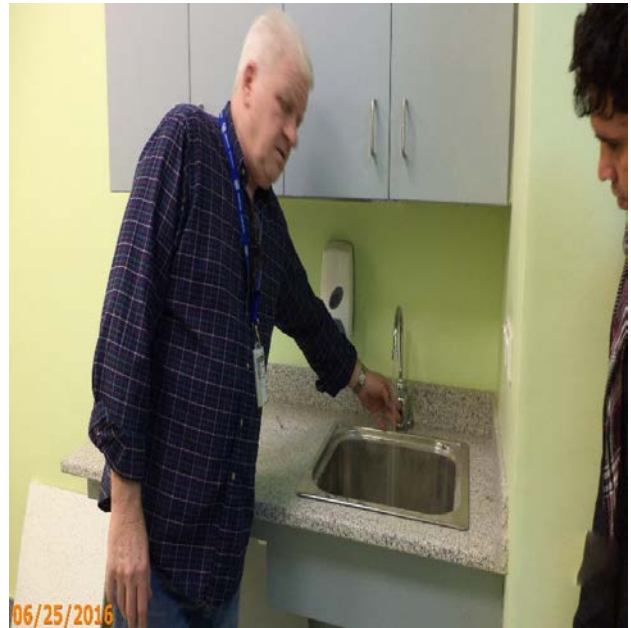
Photograph 18: The sensor of the sinks were working, MA, 06/25/2016.

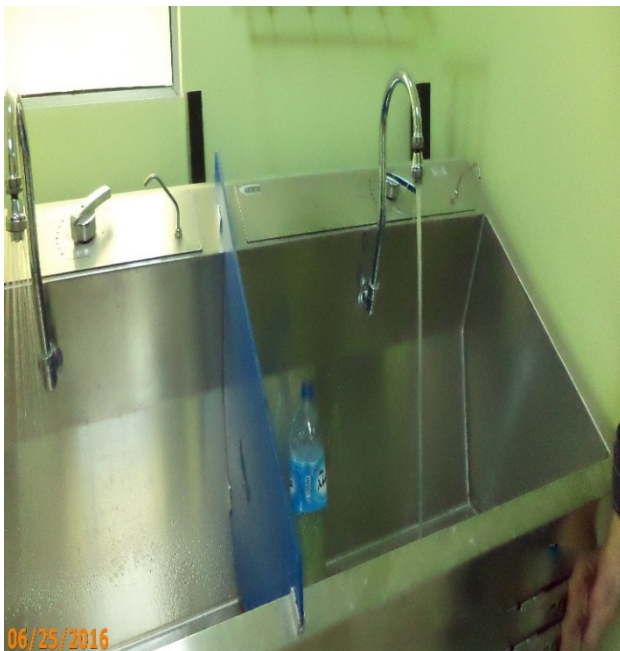
Photograph 19: The sensor of the sinks were working, MA, 06/25/2016.

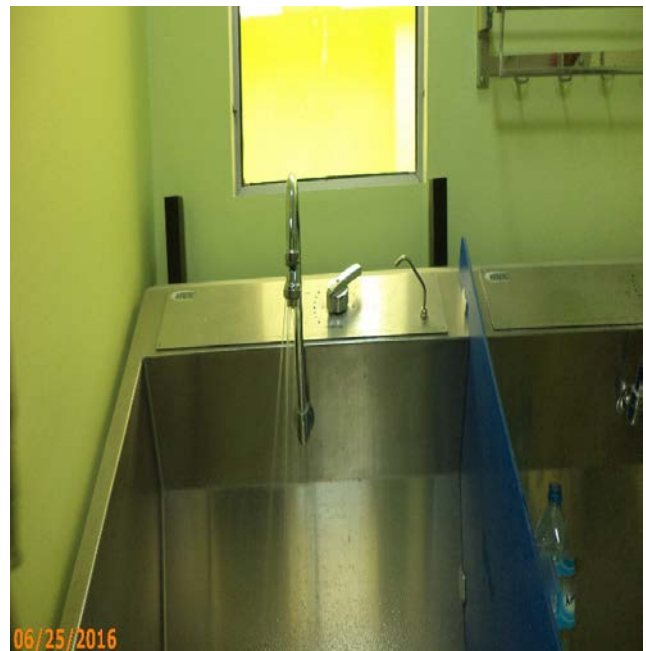
Photograph 20: The sensor of the sinks were working, MA, 06/25/2016.

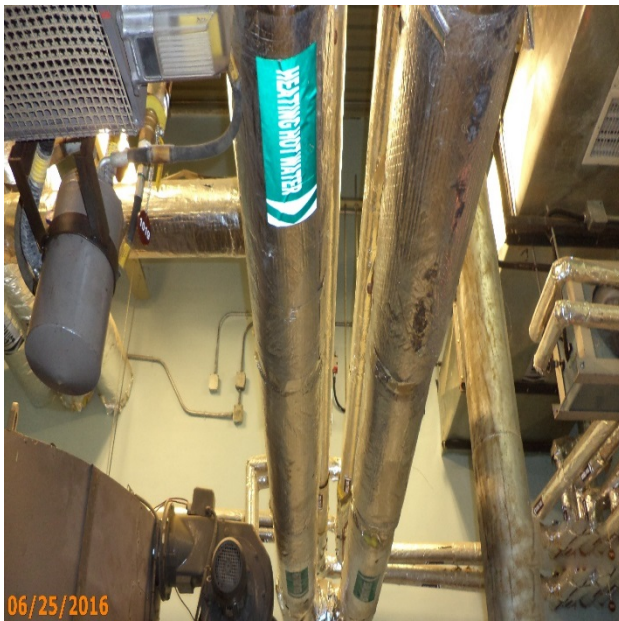
Photograph 21: The labeling of Mechanical Piping System was 100% complete, MA, 06/25/2016.

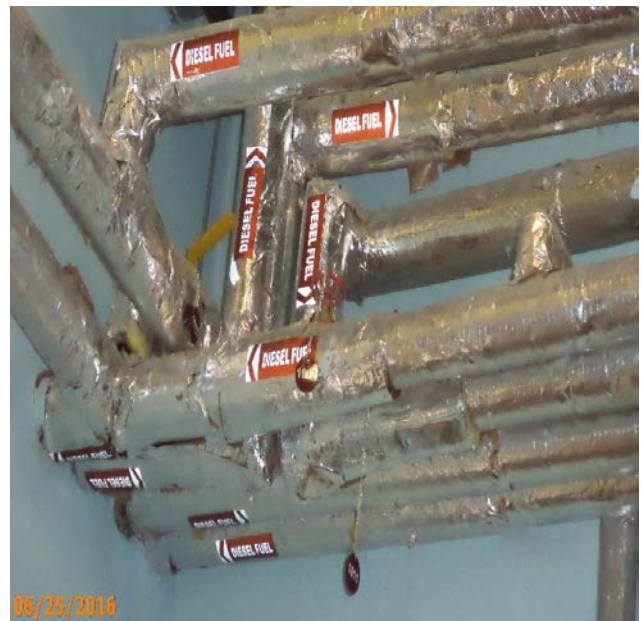
Photograph 22: The labeling of Mechanical Piping System was 100% complete, MA, 06/25/2016.

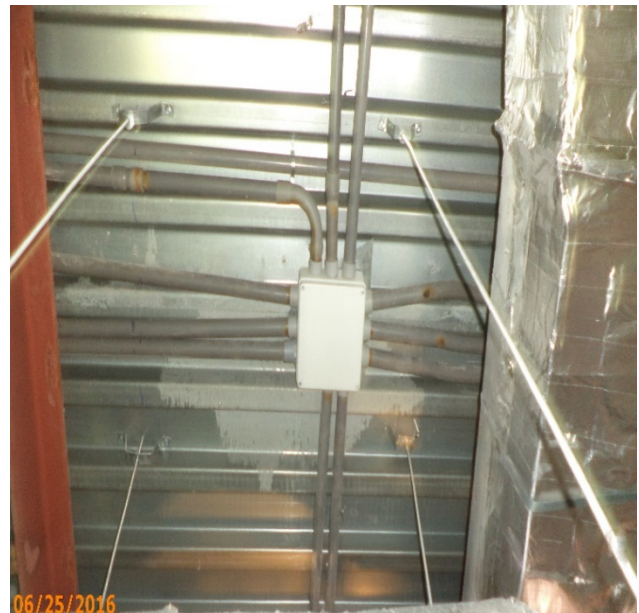
Photograph 24: The joint box and cover of installed joint, MA, 06/25/2016.

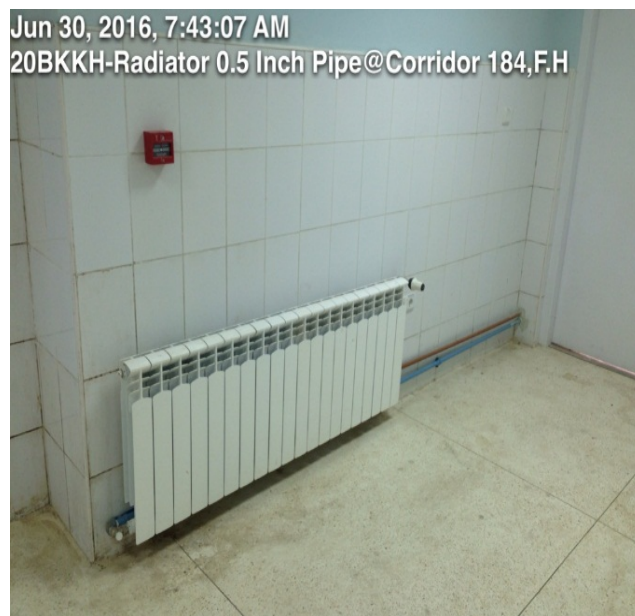
3	Radiator new installed pipe is 1 inch in the drawing, but the installed last radiator pipe is 0.5 inch at corridor 166.	On February 3, 2016 during CHEF Technical meeting IOM reported that this is the last radiator in the line and did not affect the system. The issue will be closed, after receipt of RFI from IOM on the same. <u>IOM to issue RFI (Open)</u> <u>April 5, 2016</u>	For the last radiator at Corridor 184, the contractor has installed 0.5 Inch supply and return pipes which is against drawing, but in conformance with the requirements and manufacturer recommendations for the last radiator in a network. Tt approves the RFI #72, and thus, the issue is closed.	Closed
4	Radiator fuel pumps had some problems need to be fixed and will be re-scheduling for the testing and commissioning.	Not started yet. On February 3, 2016 during CHEF technical meeting IOM informed that this is planned to be fixed during the Testing and Commissioning. <u>IOM to arrange testing (Open)</u> <u>April 5, 2016</u>	Automatic fuel transfer system and fuel pumps for burners' day tank were tested and operated in the presence of Tt QA Inspectors. It was witnessed and observed that both the system and the pumps were functioning properly.	Closed

Photograph 10: Radiator 1/2 Inch Pipes, FH, 06/30/2016.

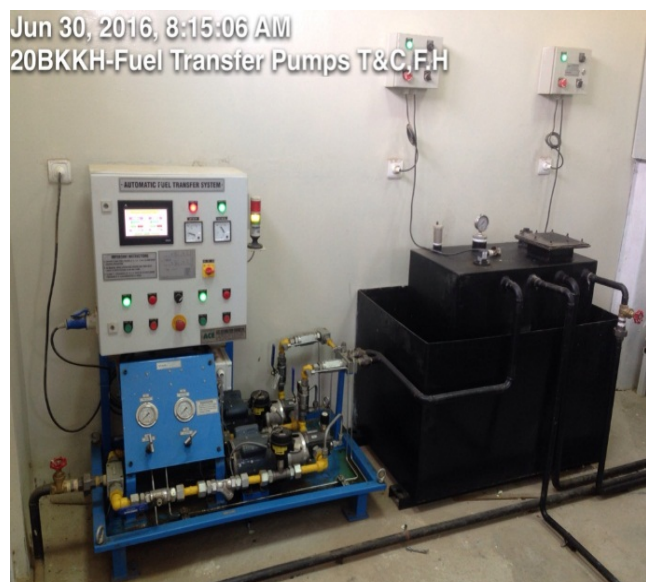
Photograph 11: Fuel Transfer System T&C, FH, 06/30/2016.

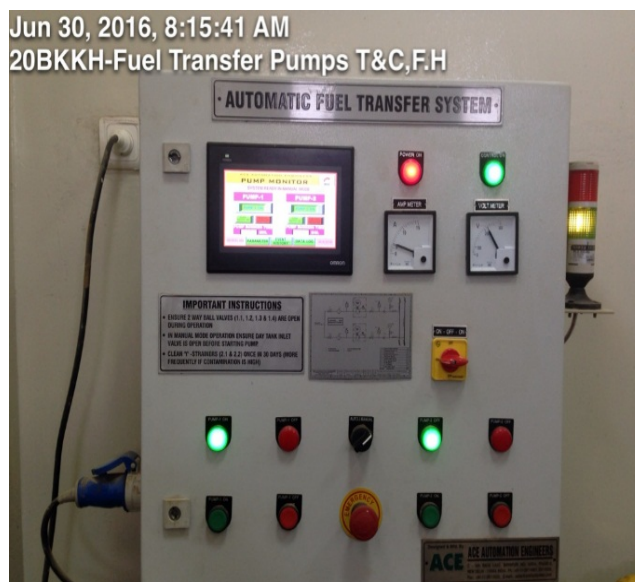
Photograph 12: Fuel Transfer System T&C, FH, 06/30/2016.

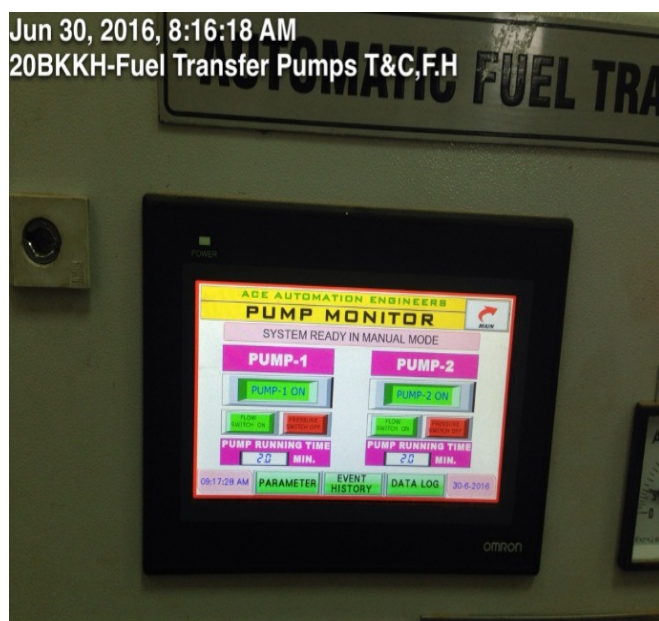
Photograph 13: Fuel Transfer System T&C, FH, 06/30/2016.

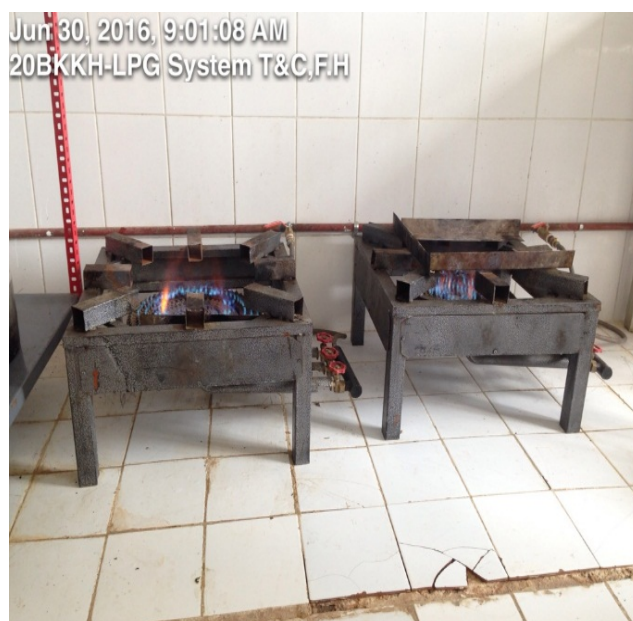
Tt Inspectors observed that liquid propane gas (LPG) was available in the tank. They also witnessed the testing and operation of LPG system and found that the system was functioning properly.

Photograph 14: LPG System T&C, FH, 06/30/2016.

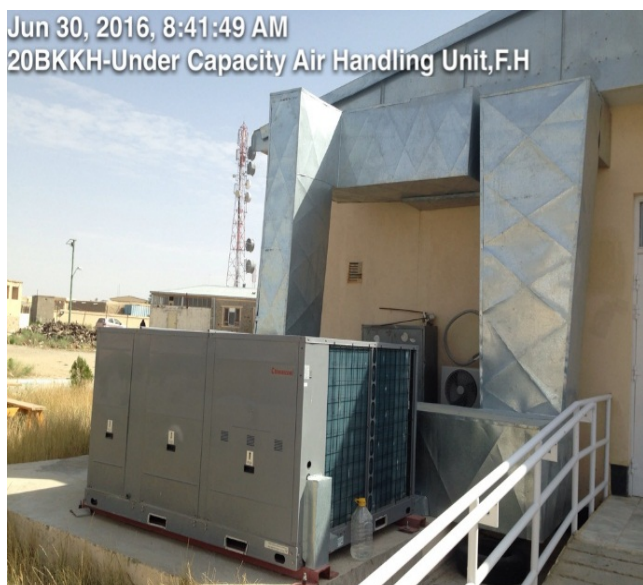
The HVAC system was tested and commissioned previously and witnessed by USAID/IRD. It was found that the system and its parts were working properly, but the air flow at the furthest point of the facility was minimum and insufficient. After detailed inspections by IOM QC, it was reported that the installed AHU was of insufficient capacity, resulting in lower air transfer for the areas of the facility located furthest from the AHU. IOM has promised replacement of the AHU with higher capacity as specified in the design. Tt Inspectors visually checked and observed that IOM has not replaced the under-capacity AHU as of month of June 2016.

Photograph 15: Under Capacity AHU, FH, 06/30/2016.

IOM QC said that they will replace the AHU with sufficient capacity as per contract requirements during the warranty period.

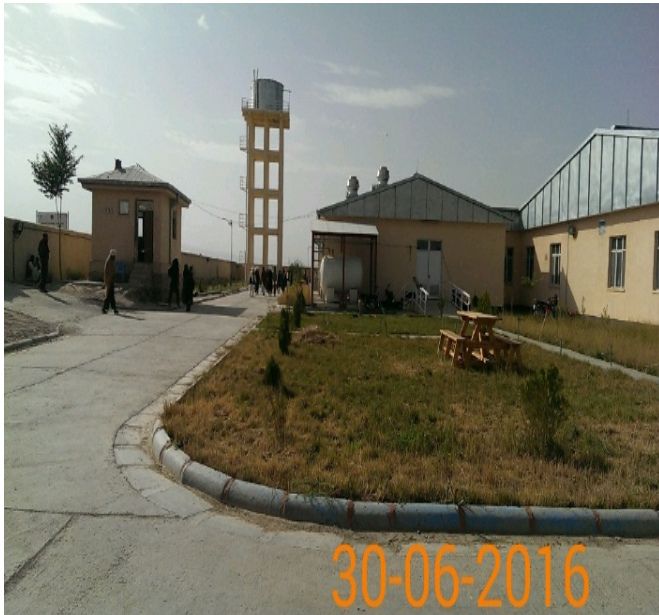
Photograph 17: View of the site which was observed as having been properly cleaned, FH, 06/30/2016.

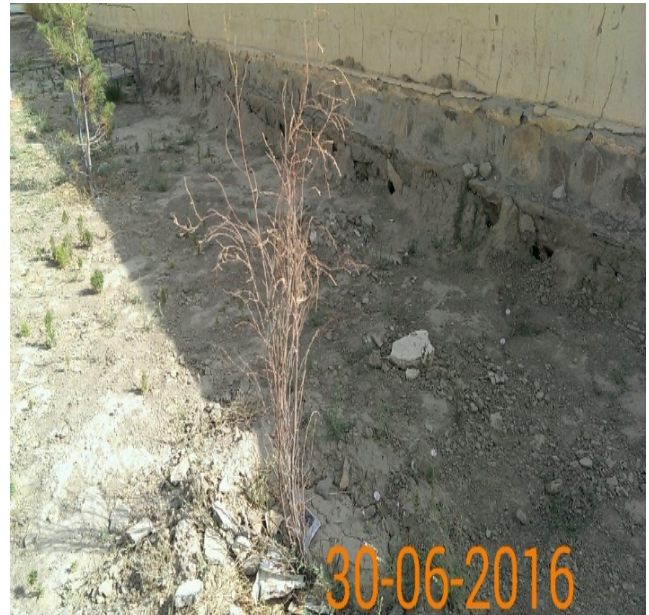
Photograph 18: View of a dead tree on site which needs to be removed and replanted, FH, 06/30/2016.

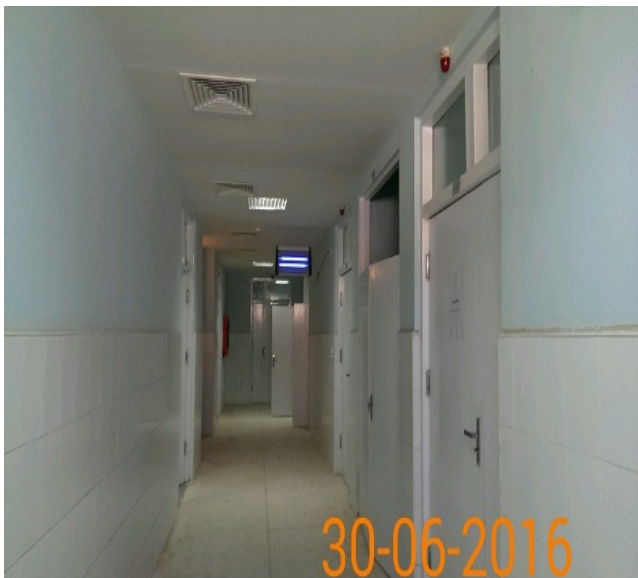
Photograph 19: View of the interior site which was observed as having been properly cleaned, FH, 06/30/2016.
